Subject: Slope Erosion Hazard Assessment - Deltini Subdivision, Primrose, Ontario

TABLE 4.1 - Slope Inspection Record1. FILE NAME / NO. **181-01582-04**INSPECTION DATE (DDMMYY): **21/02/23**

TABLE 4.2 - SLOPE STABILITY RATING CHART

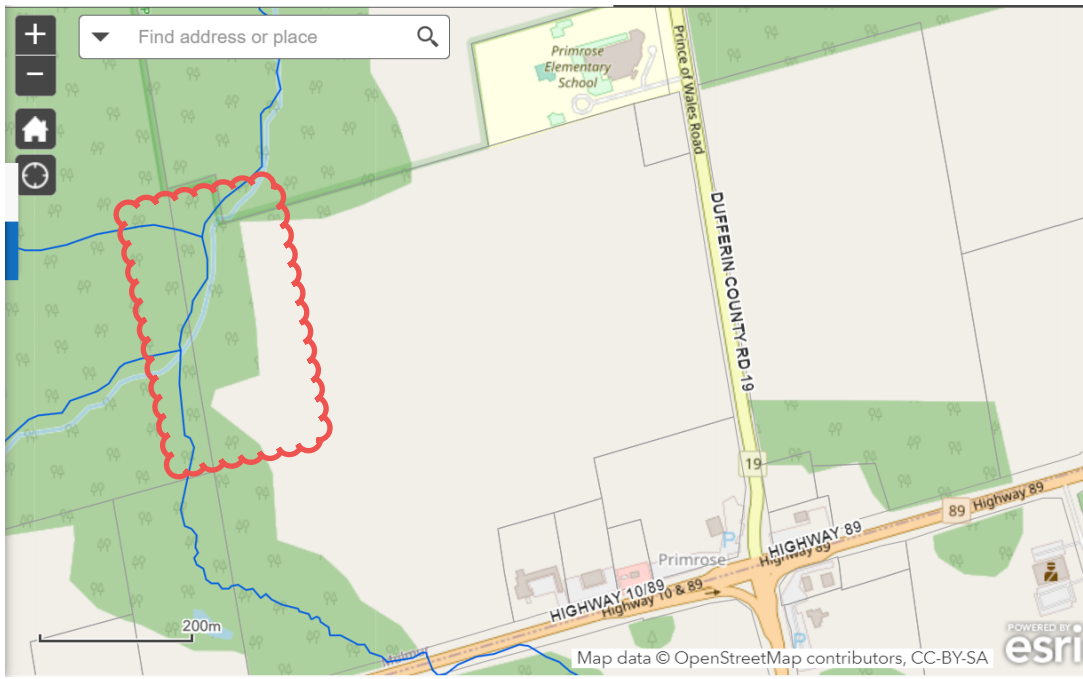
13. Plan Sketch of Slope

GULLY **One (1) gully observed, extending from toe of slope to top of slope. Water in gully flowing down towards creek.**

STREAM, **CREEK**, RIVER **Confined creek at base of slope. Tributary of the Boyne River. Flows from south to north.**

TOP **No erosion noted across top of slope, with the exception of One (1) gully which extended from the creek to top of slope.**

FACE **No erosion noted across face of slope, with the exception of One (1) gully which extended from the creek to top of slope.**

BOTTOM **Generally no erosion at the toe of the slope. One (1) gully extending from the creek to the top of slope was observed. Some isolated locations were slightly eroded due to the active watercourse, with tilted/fallen trees observed.**

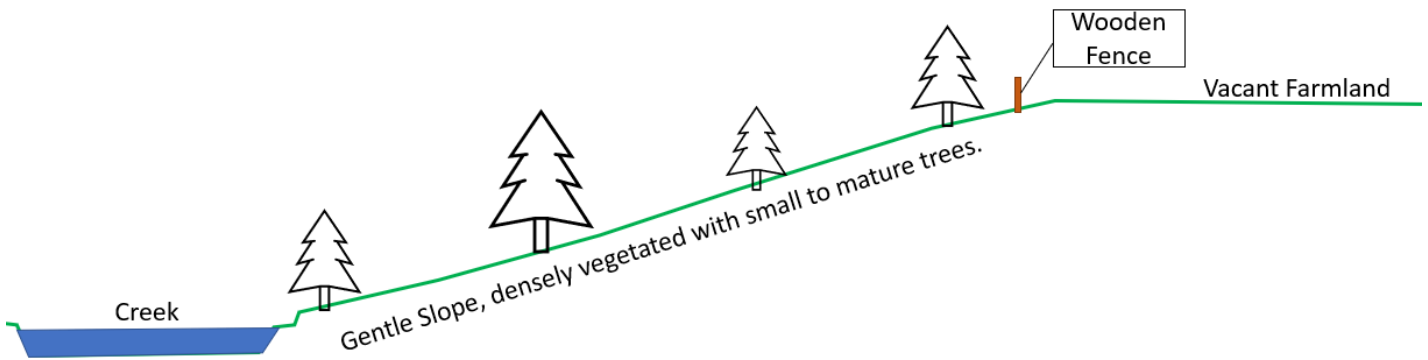
14. Profile Sketch of Slope

As per the cross-section data provided to our office, it is noted that the slope is very gradual and relatively flat at the site, with slope percentages generally ranging between 5% to 12% (about 20H:1V to 8H:1V), but also flat in areas (0%). The steepest portion of the slope, in only one area, has an inclination of about 20.1% (4.8H:1V).

HEIGHT • **3 - 6 m** • **6 - 10 m** • 10 - 15 m • 15 - 20 m **5m - 6m average height.**
 • 20 - 25 m • 25 - 30 m • > 30 m

• **4:1 or flatter**
25 % 14°• up to 3:1
33 % 18°• up to 2:1
50 % 26°• up to 1:1
100 % 45°• up to :1
200 % 63°• steeper than :1
> 63°
