**Pine River Tributary
Flood and Erosion
Hazard Assessment**

January 24, 2023

**Re: Armstrong Estates - Mansfield, ON
Fluvial Geomorphological and Hazard Assessment**

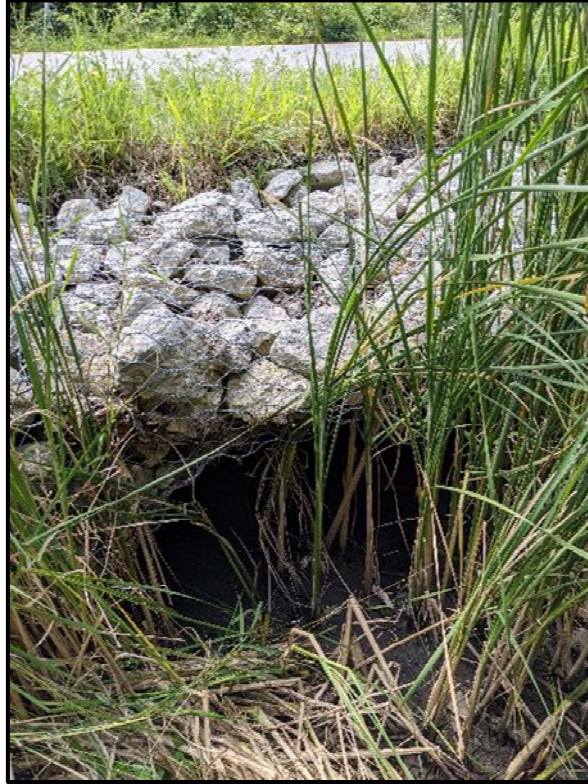
PHOTOGRAPH NO.: 1

FROM: Immediately downstream of road, in channel.

LOOKING: At downstream end of HE Pipe. Note cattails and sediment.

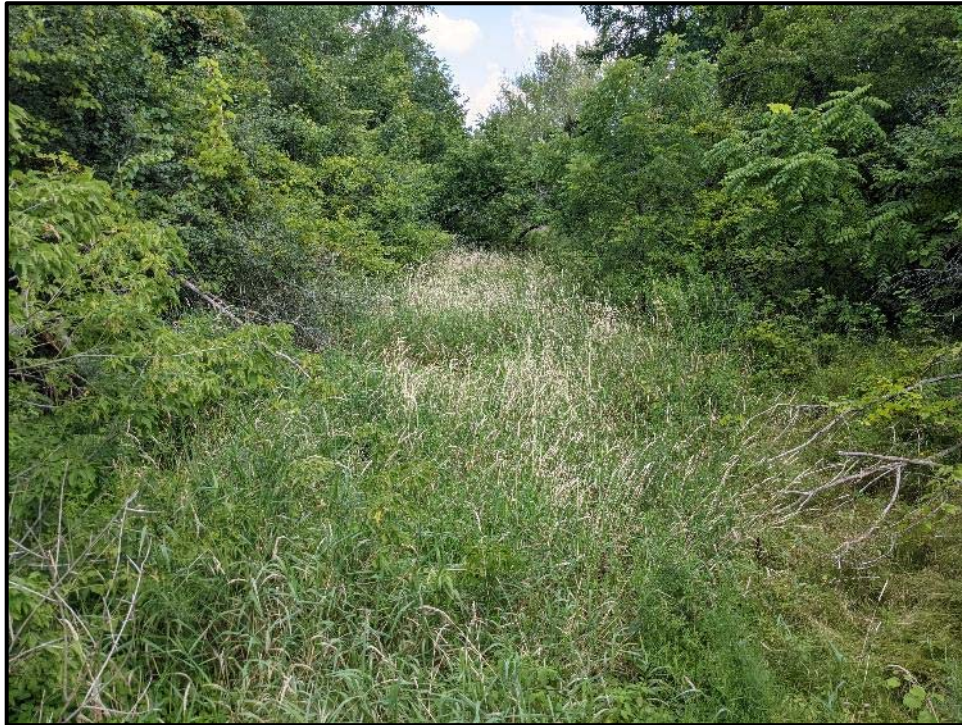
PHOTOGRAPH NO.: 3

FROM: In channel valley.

LOOKING: Downstream through valley. No defined channel visible.

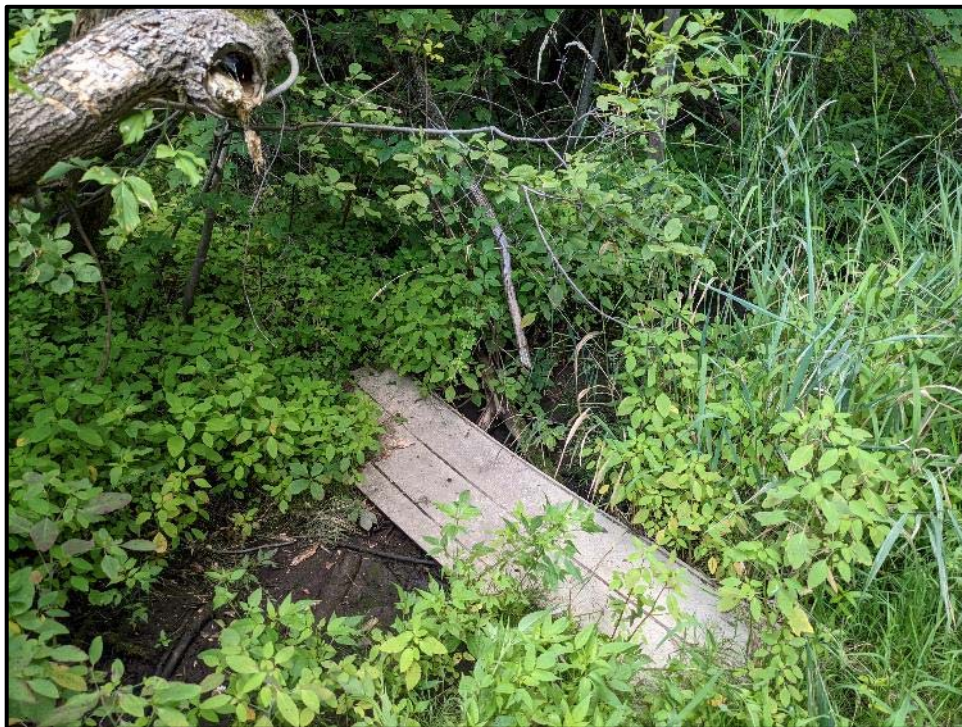
PHOTOGRAPH NO.: 4

FROM: Channel in upper middle part of site.

LOOKING: At potential flow path or low lying wet area in valley.

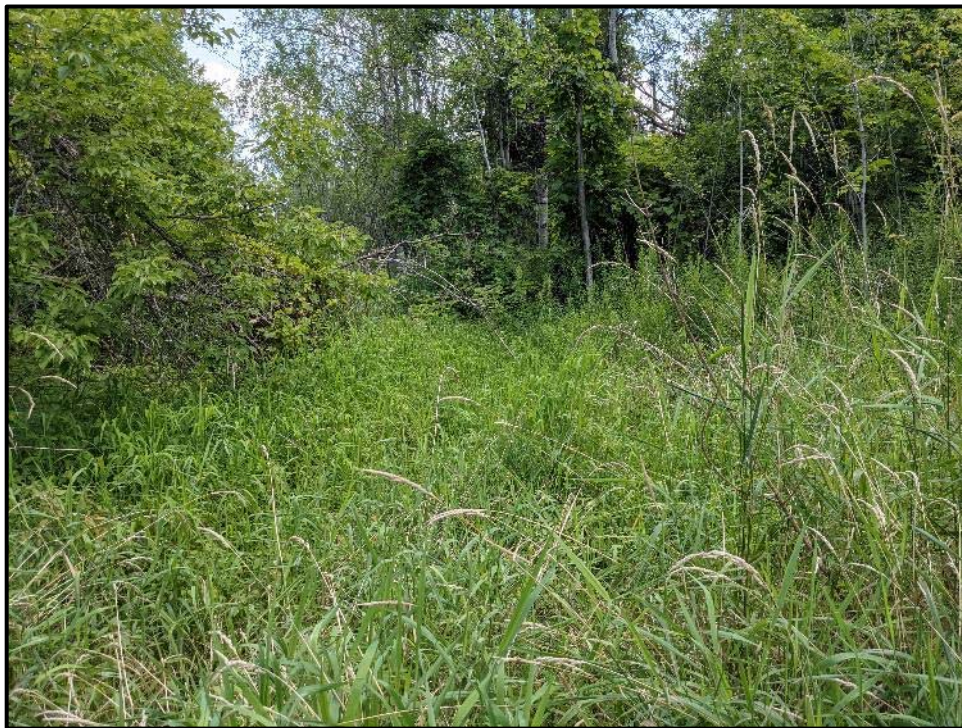
PHOTOGRAPH NO.: 5

FROM: Upper to middle of site.

LOOKING: Along valley corridor. Heavy grasses, no distinguishable channel.

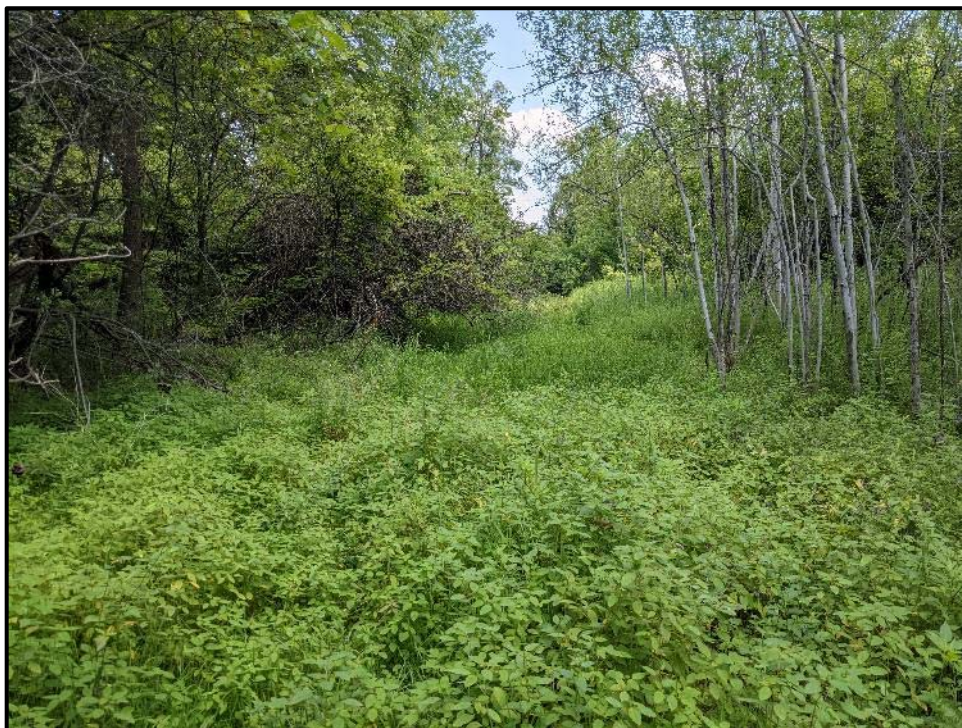
PHOTOGRAPH NO.: 6

FROM: Upper to middle of site.

LOOKING: Along valley corridor. Heavy grasses, no distinguishable channel.

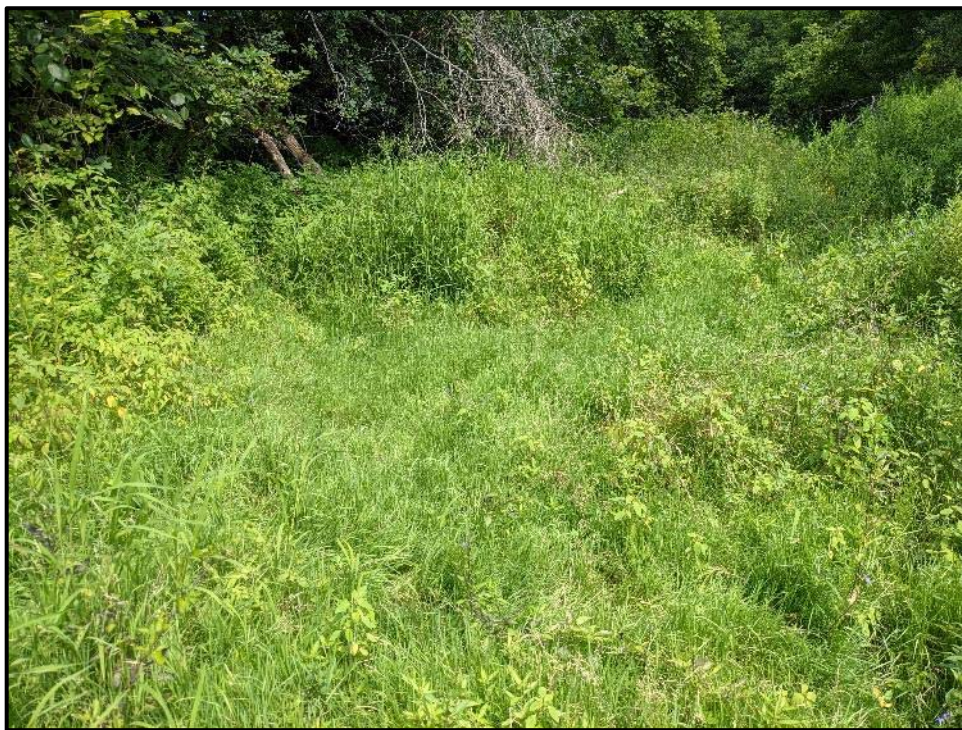
PHOTOGRAPH NO.: 8

FROM: Valley in middle of site.

LOOKING: Along valley corridor. Heavy grasses, no distinguishable channel.

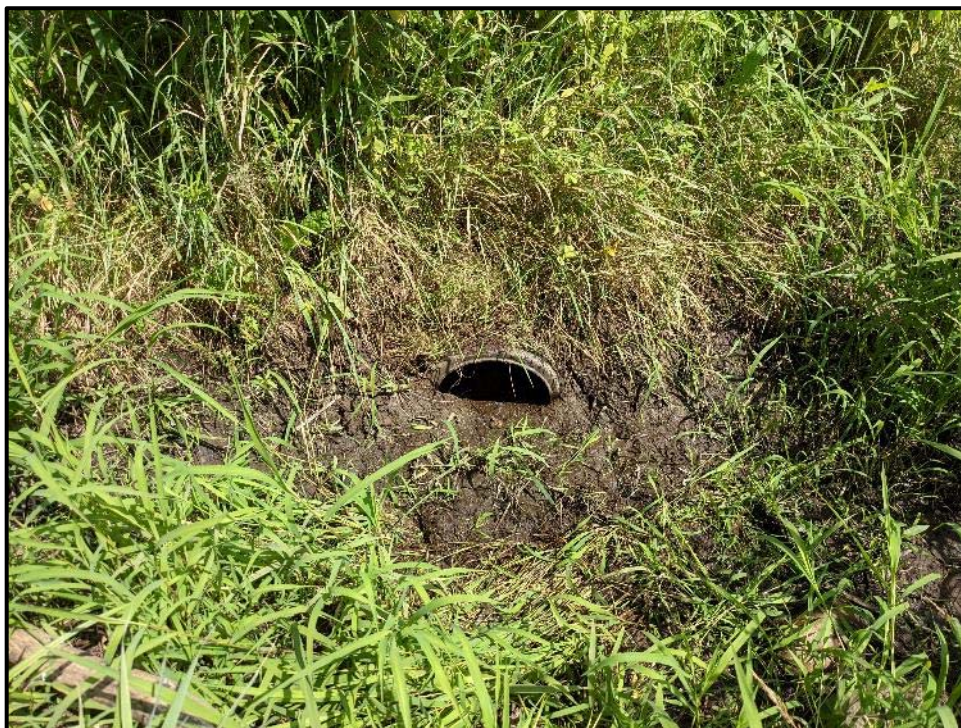
PHOTOGRAPH NO.: 10

FROM: Immediately upstream of farm lane crossing.

LOOKING: At small pipe (~300) that conveys flows through crossing.

One crossing of the tributary is proposed for the residential development site. There is an existing farm lane crossing on the property (**Figure 3**). Any flows from the tributary are conveyed through

the crossing by a 300 mm pipe. It is recommended that the current location of the crossing be used for any future crossings of the tributary. In addition, the culvert at the crossing will be sized to include 1 metre offsets from the low flow channel in order to accommodate any future movement of the tributary. The culvert should also be embedded in the ground and include 100mm of stone substrate through it. The final culvert size will be determined by the hydraulic modelling but will ensure that the erosion offset from the channel is sufficient for the tributary.

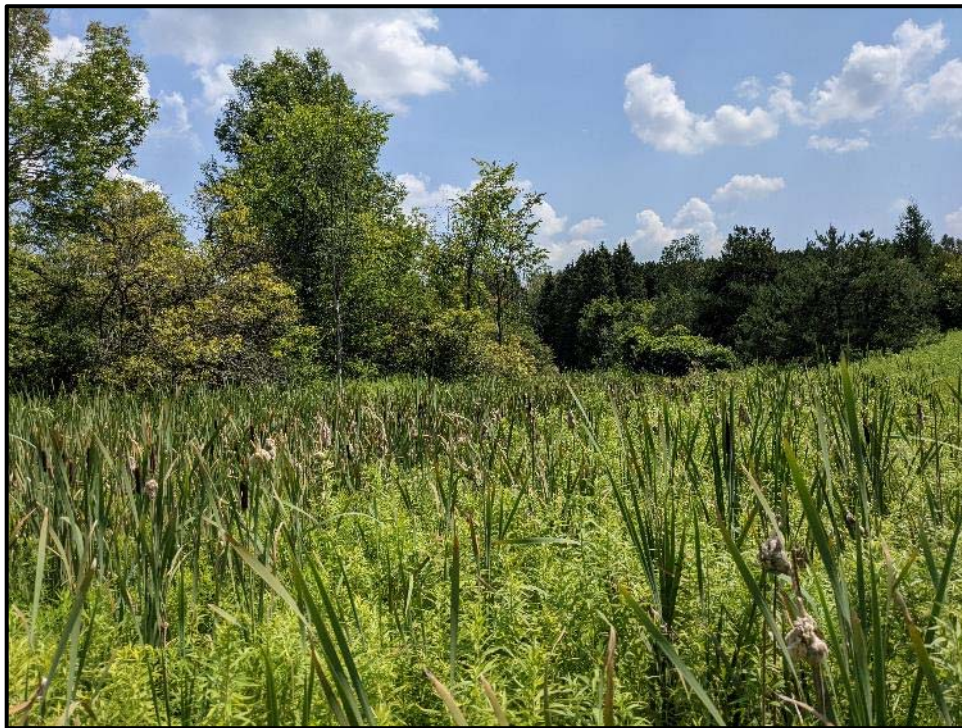
PHOTOGRAPH NO.: 12
FROM: Lower middle end of site in valley bottom near drainage path.
LOOKING: Along valley corridor. Heavy cattails and vegetation, area is damp.

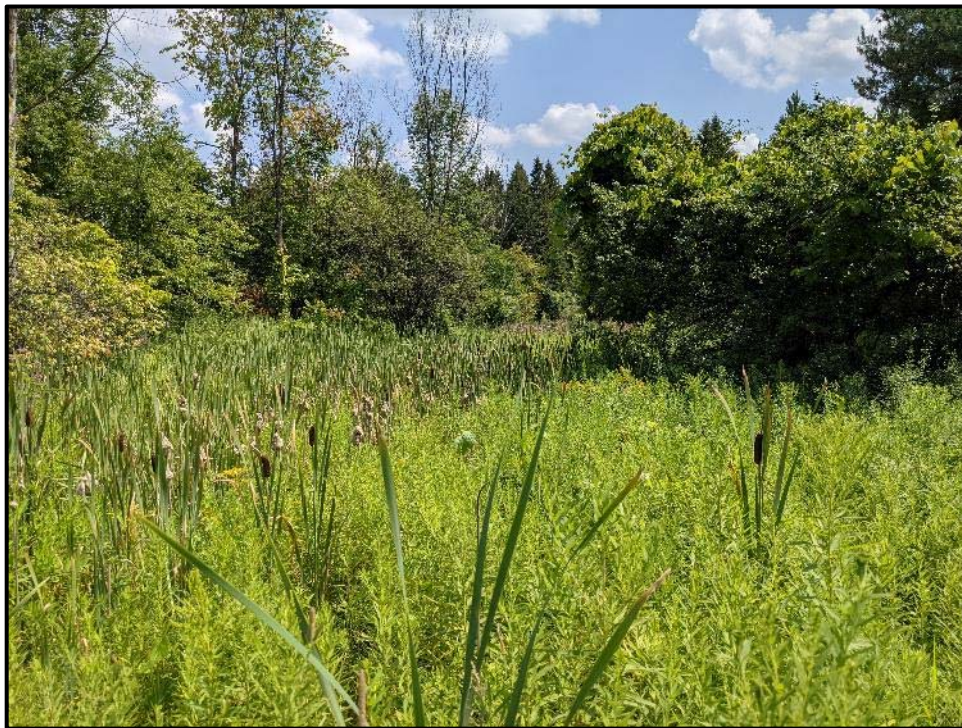
PHOTOGRAPH NO.: 13

FROM: Lower middle end of site in valley bottom near drainage path.

LOOKING: Along valley corridor. Heavy cattails and vegetation, area is damp.

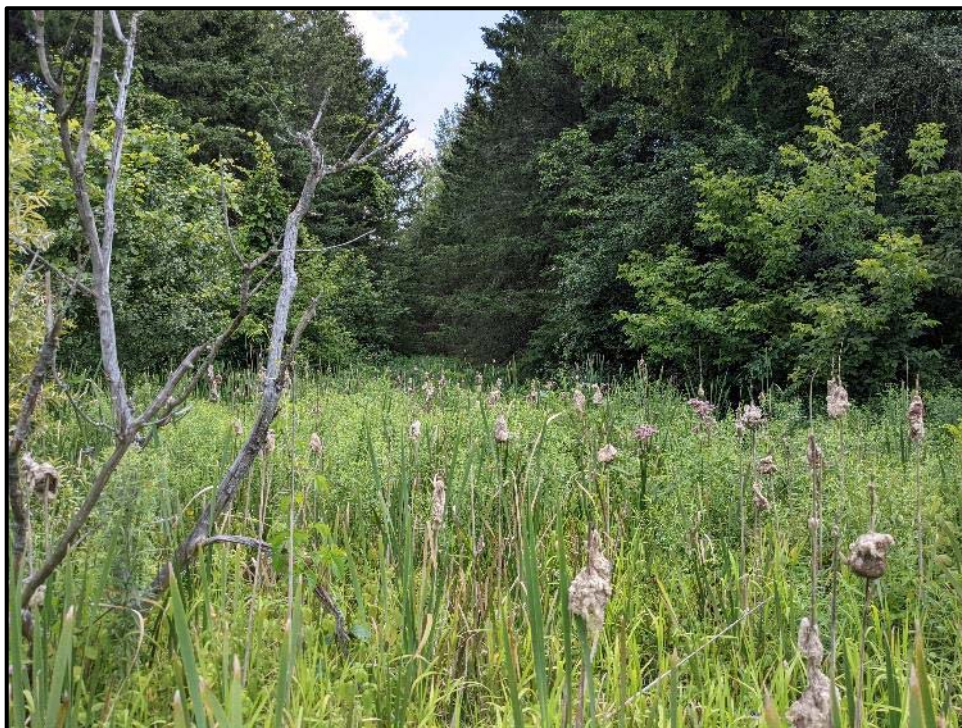
PHOTOGRAPH NO.: 14

FROM: Lower end of site in drainage path.

LOOKING: Along valley corridor and at the end of the property limits. Slope increase.

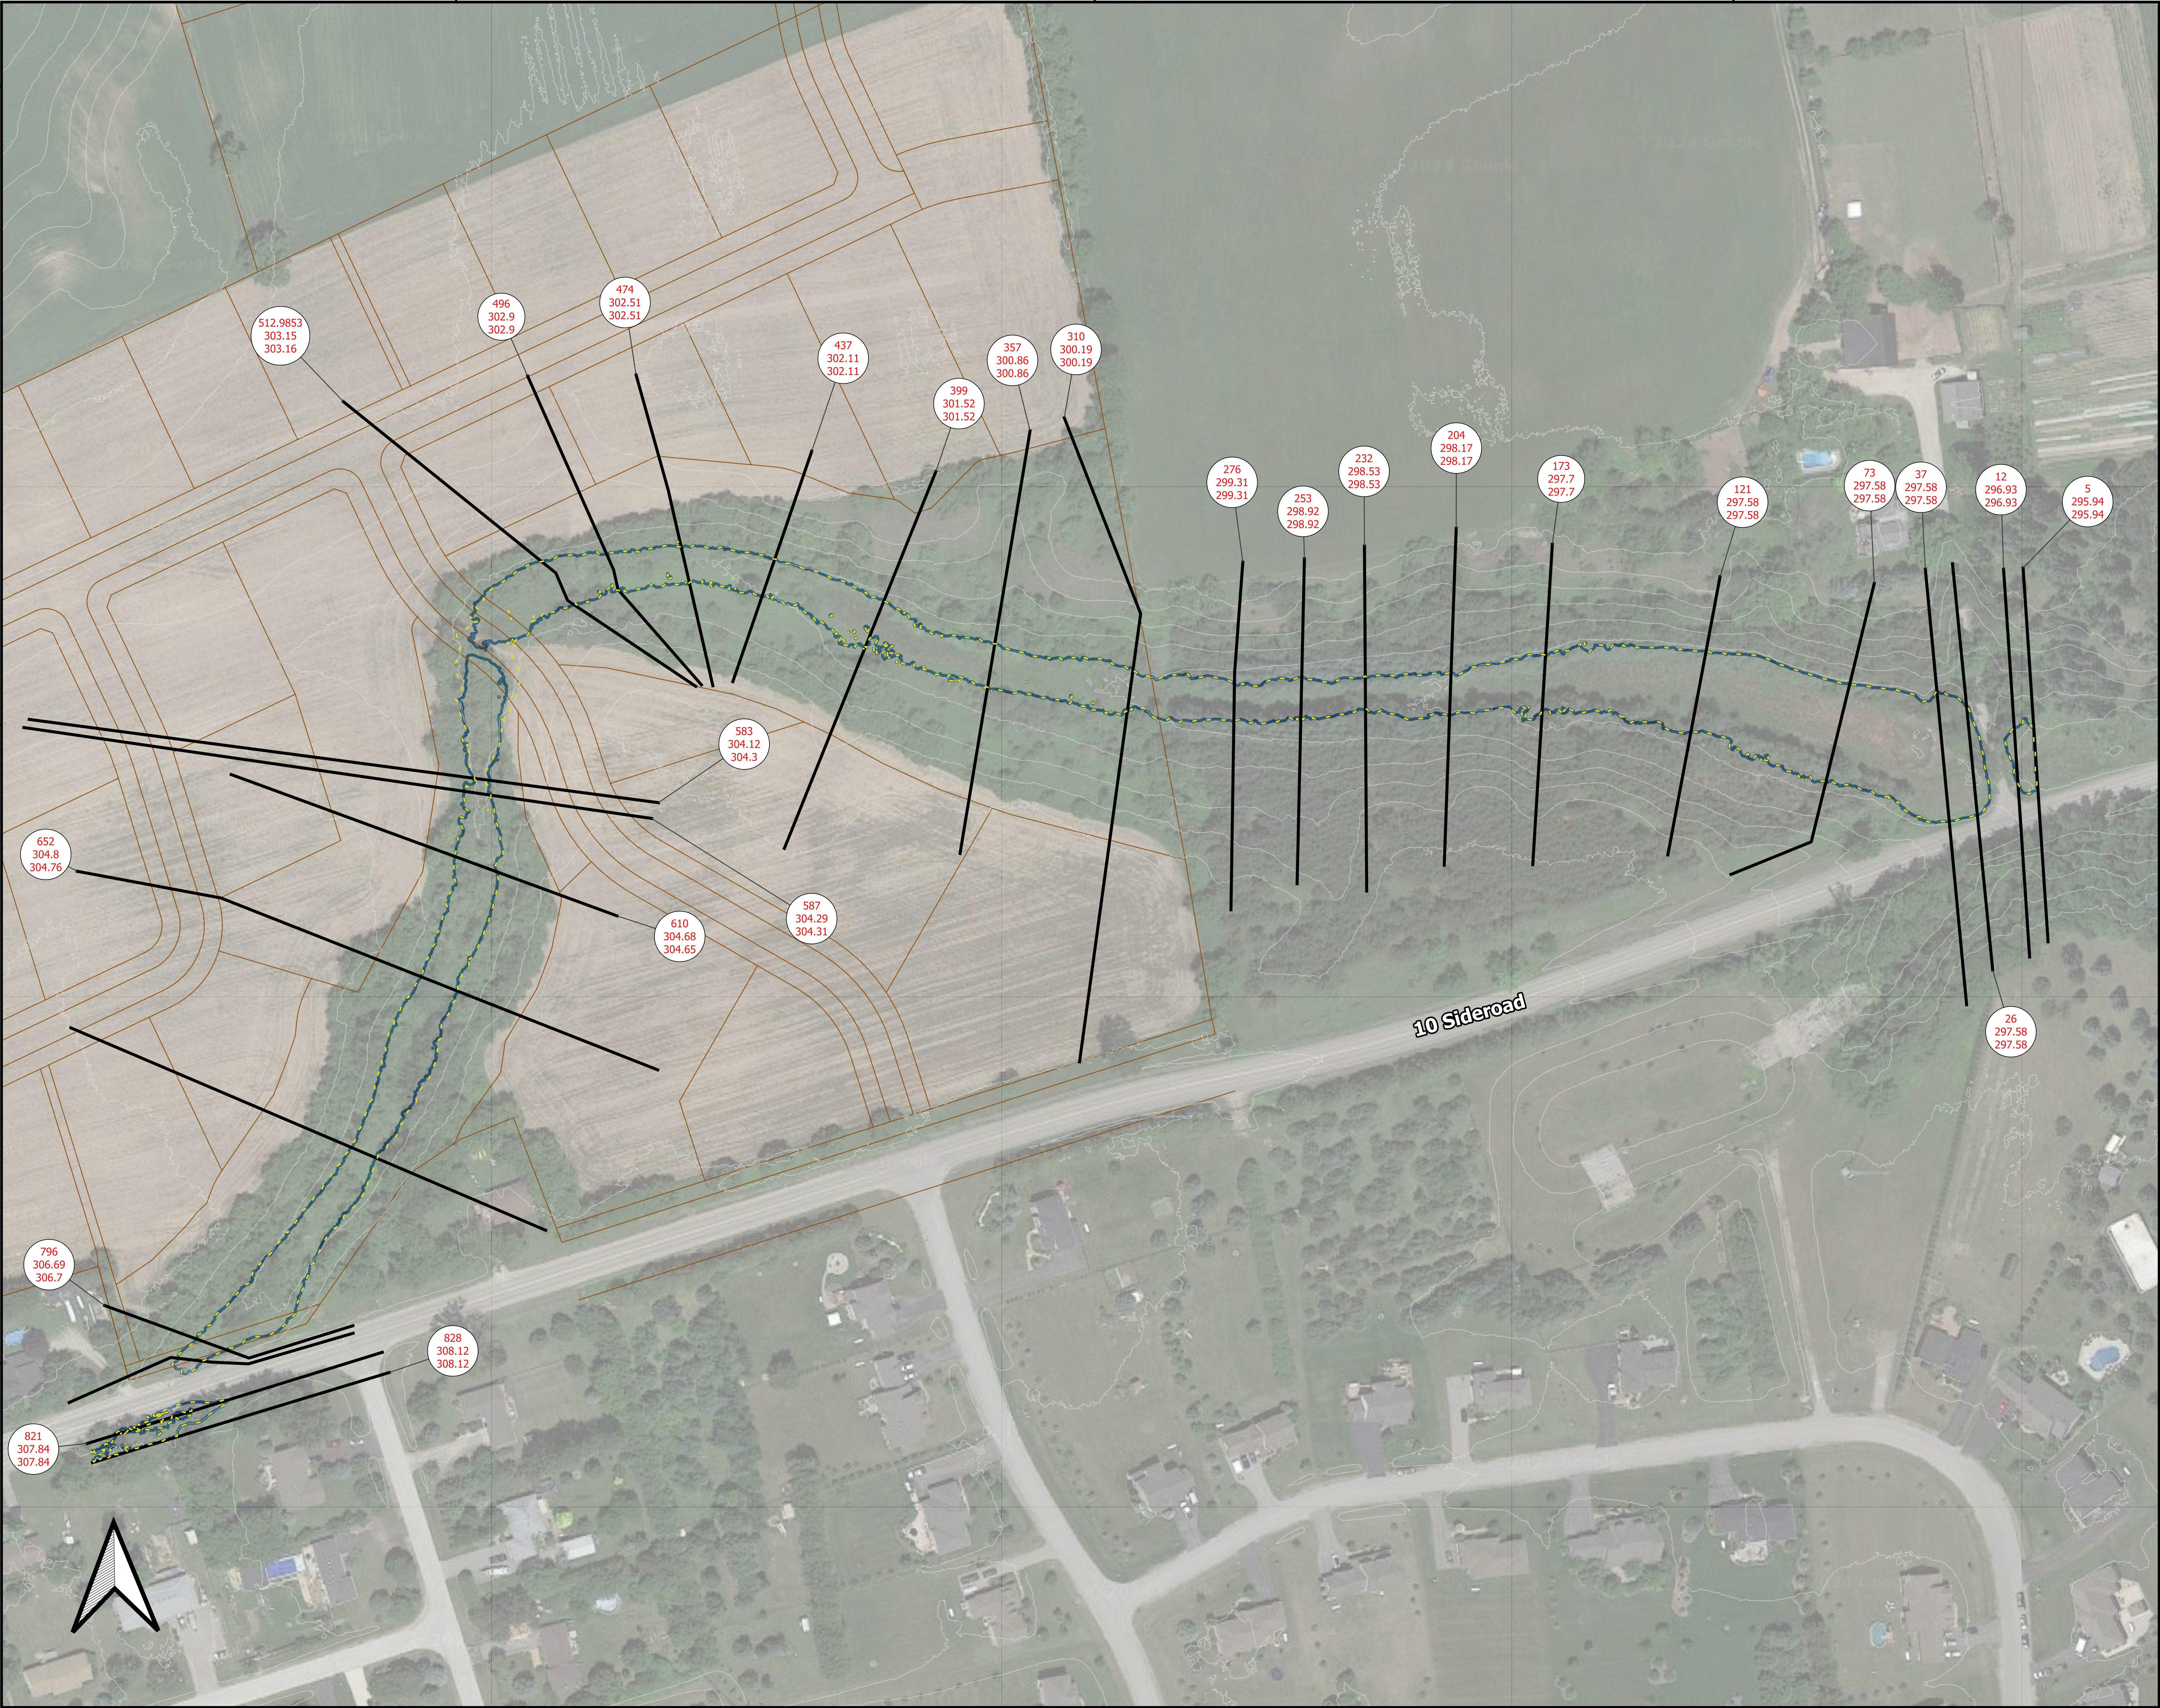
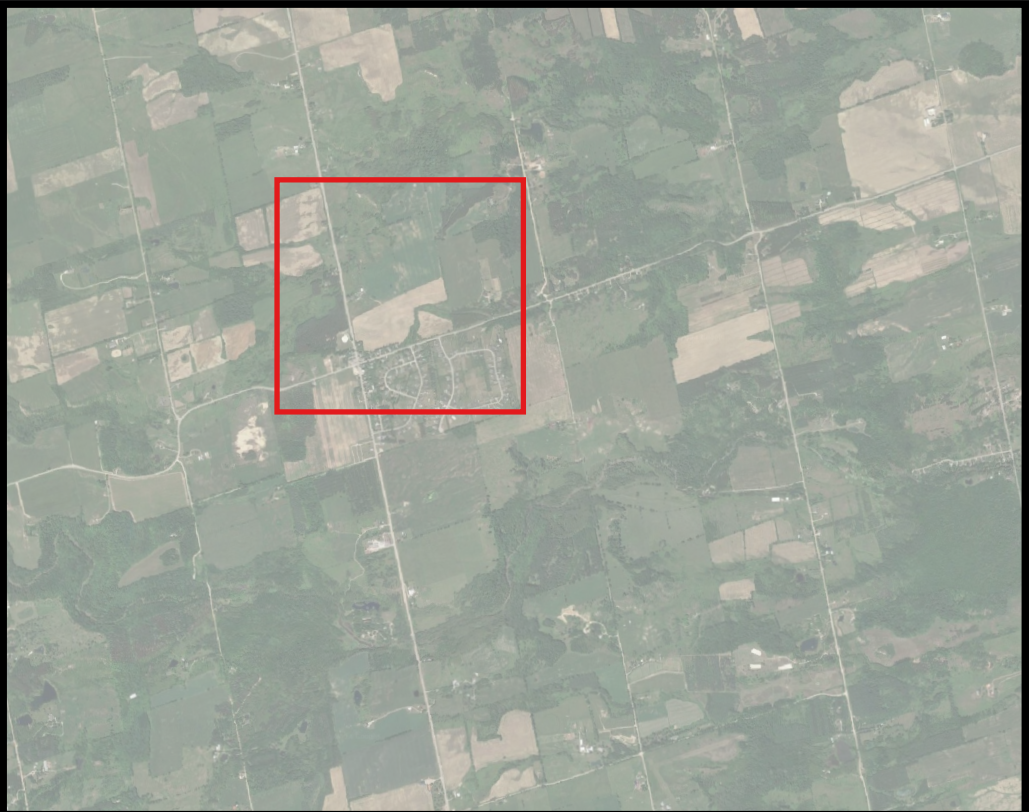
Flood Hazard Mapping in Mansfield, ON

River Station → 121
Existing Water Level → 297.58
Proposed Water Level → 297.58

Under existing conditions, the water surface elevation (WSEL) immediately downstream of County Rd 17 is 306.98 for the Regional Storm. The Regional Storm WSELs are greater than the 100-year Storm in all areas. The water surface elevations at key locations under existing and proposed conditions are shown in **Table 4**. The existing crossing on the site has a 0.3 m culvert and an embankment height of 303.83 m. Various culvert sizes were modelled in order to determine a size that would not overtop the proposed road or increase the upstream flood risk. A concrete box culvert that is 3m wide and 2.4 m tall would be sufficient to achieve this. The culvert was embedded 10% to accommodate substrate within the structure. Under these proposed conditions, the road elevation will be 305.85m, which results in a 304.3 m Regional Storm elevation upstream of the proposed crossing. The water surface elevations at the downstream end of the property have not changed and remain at 300.19m. The Regional Storm floodplains under existing and proposed conditions are shown in **Figure 5** and full floodplain map are seen in **Appendix C**.
